WEATHERING OF POLYMER COATINGS, FORMED ON THERMALLY MODIFIED WOOD

Panayot A. Panayotov – Jivko V. Georgiev

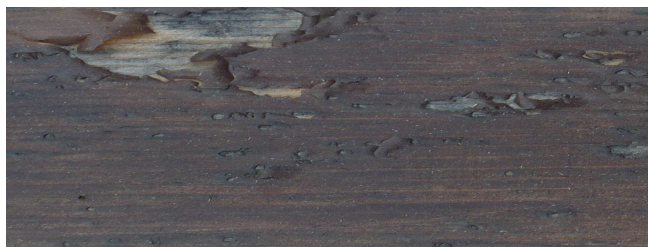
On the standing has three different series with samples. The first one included 6 radial and 6 tangential thermally treated spruce samples, which are coated with waterborne coating (HTSR). During two years exposure the samples are measured and are noticed visible differences in coating and in wood. The first visible changes come in the end of the first year and they are result of hailstorm (Figure 2). The coatings have small craters on the

surfaces, which accelerate the destructions in the next months. These local defects grow in the end of the second year, especially on one sample (Figure 2). The coating loses adhesion to wood in these spots and whole zones of it are undertaken. The ends are not cracked, but in tangential samples have small curving in the ends.

Figure 2 Destruction of coating and wood on sample HTSrR-2 after 2 years

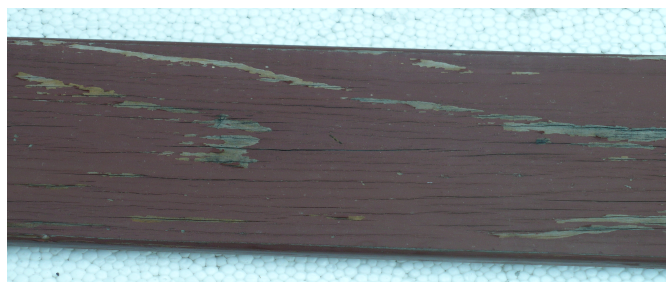
During two years exposure the samples are measured and are noticed visible differences in coating and in wood (Figure 3). The samples haven't any visible defects after hailstorm in the end of the first year.

Figure 3 Destruction of coating and wood on sample HTStT-9 after 2 years

The alkyd coating has perfect elasticity because it is modified with line oil. In the end of the second year the colour of coating is changed, there are big crackles in the ends and the coatings are torn on the border between spring and summer wood. The ends of the tangential samples are curved more than the waterborne painted ones. The coatings are particularly destructed. The third group consists of 3 radial and 3 tangential thermally treated spruce samples without any coatings (HTSU). The samples are measured and noticed the visible differences in wood during two years outdoor exposure. Uncoated thermally modified wood has good structure stability during all exposure. The colours of the samples are extremely greyish in the ninth week.

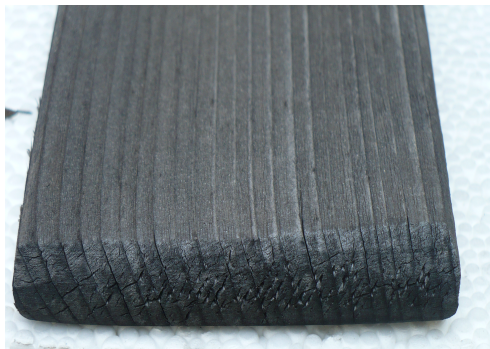
Figure 4 Destruction of wood on sample HTSrU-10 after 2 years

Crackles in the ends appear in sixth month and become well defined in the end of the second year (Figure 4). The wood is with underlined fibres after one and half year. The ends of tangential samples are curving like alkyd painted ones. All of destruction processes are more intensive in tangential samples.
