WEATHERING OF POLYMER COATINGS, FORMED ON THERMALLY MODIFIED WOOD

Panayot A. Panayotov – Jivko V. Georgiev

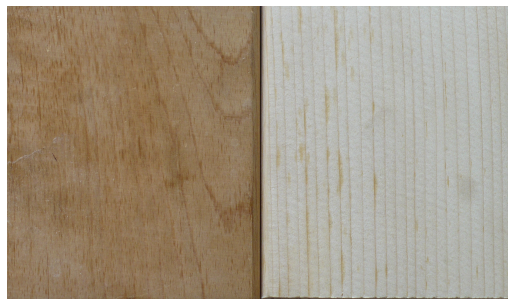
All results for thermal treatment of spruce wood are in table 1. From this table is visible that spruce wood loses 2.55-8.45% mass in this treatment. The result of treatment is that the colour of samples becomes brown with well-defined fibres (Figure 1). After conditioning for 7d, the samples have with 3.58-4.73% humidity.

Figure 1 Spruce samples; at left thermally modified wood; at right natural spruce
